Study and maximization of the outer ring rib robustness in multi-row cylindrical roller bearings used in roughing mill stands

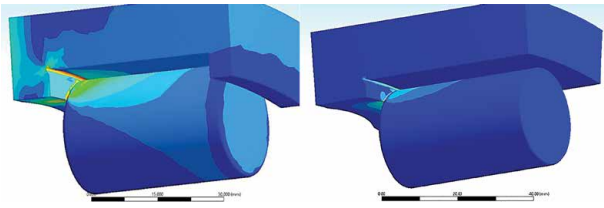
+ Comparative FEM analysis of AF2D (left) vs GB2D (right) with roller pushing axially on the rib

RKB performed a comparative Finite Element Method (FEM) analysis to evaluate the stress distribution in both bearing designs under axial loading acting on the inner surface of the outer ring rib.

The FEM results showed that the increased rib width in the reinforced design reduced the Von Mises stress in the most critical section, showing a reduction in the notch effect. Based on the analysis, RKB recommended field testing of the reinforced design in the customer's roughing stand application.
